An Independent Analysis of a Glovebox Glove Failure Incident

Nuclear Material Technology Division
Los Alamos National Laboratory,
Los Alamos, NM 87545
(505) 665-7616

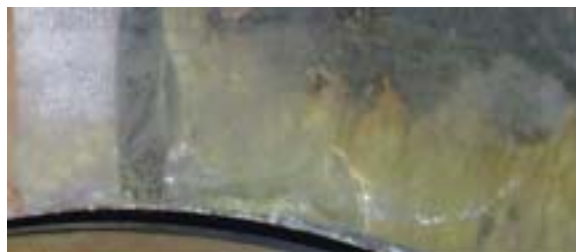
Figure 2. Crack Above Glove Port of the Glovebox.

Analysis of Glovebox and Glove [3] An approximate six-inch crack was found in the glass above the right, upper-middle glove port of the glovebox, as shown in Figure 2. This was the port next to the blown-off glove. No other damage was found in the glovebox. Inspection of the fire screens in both boxes revealed that the screens were almost completely clogged with solid residues, as shown in Figure 3.

According to the Incident Investigative Report, the direct cause of the incident was the overpressurization of a glovebox due to a rapid but non-explosive decomposition of chemical compounds while subjected to heat [3]. Whether an explosion occurred or not is not particularly important. Nevertheless, enough stored energy was released to crack the glass in the glovebox and tear a glovebox glove. The molar ratios of nitrate to ammonium on the two fire screens indicate the solid residue was ammonium nitrate, with a slight excess of the nitrate. Splattering or aerosol transport occurred during the incident, since the fire screen materials contained the same elements found in all other samples. Ammonium nitrate solution is capable of this type of energy

- The solution being concentrated contained significant amounts of ammonium nitrate.
- The solution was allowed to evaporate to dryness, thereby allowing the temperature to rise above 210°C.
- This situation also presents the possibility of forming low-density areas such as bubbles, in molten ammonium nitrate or solutions, which may increase the possibility of an explosion and enhance the propagation of an explosion.
- At this point the solution rapidly decomposed into gases that included various colored oxides of nitrogen.

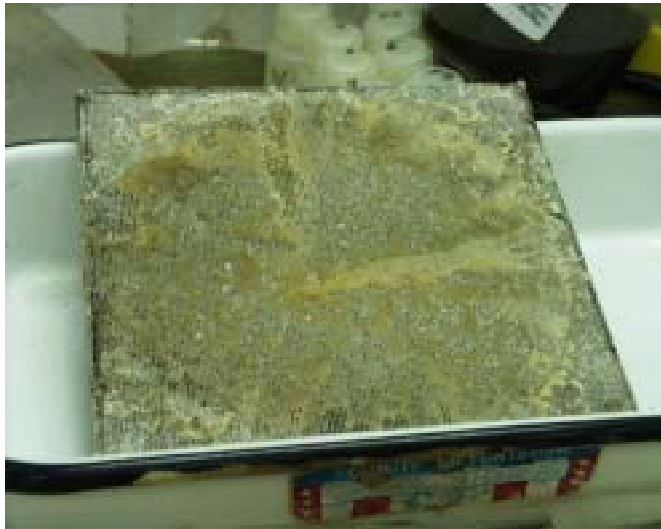
Figure 3. Fire Screens Clogged with Solid Residues.

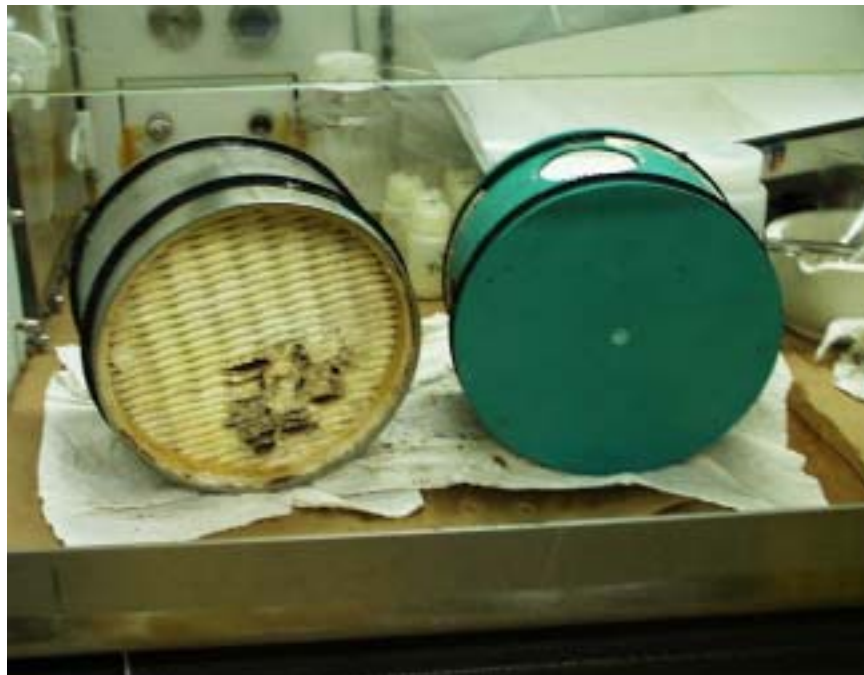
Inspection of the High Efficiency Particulate Air (HEPA) filters showed that the filter media in the upstream side of the filters was significantly deformed and thus allowed a significant flow of air through the filter without having to pass through the filter media, as shown in Figure 4.

Figure 4. Upstream Side of Deformed High Efficiency Particulate Air (HEPA) Filter.
